Final Report

A Detailed Failure Analysis of the Ball Bearings

From a Model 1631 Tape Recorder

New Hampshire Ball Bearings, Inc.

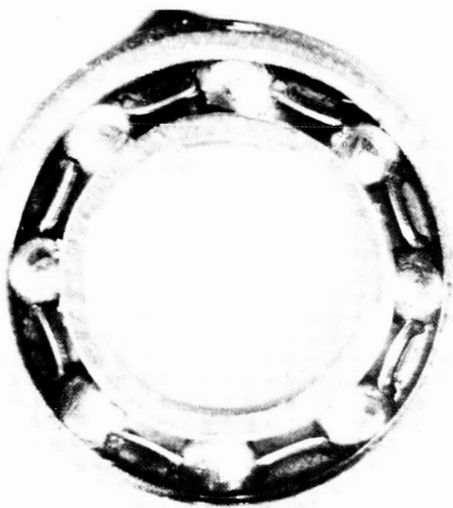
Figure 1  
Jack Shaft Bearing No. 1

Dry curls of lubricant residue  
on the inside of the bearing  
surfaces.

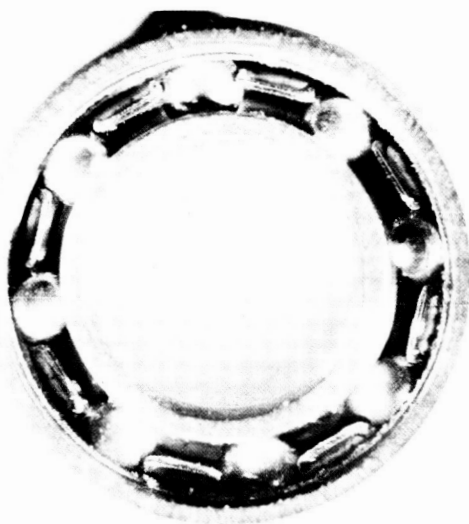
Figure 2  
Jack Shaft Bearing No. 2

Grainy, brown lubricant residue  
with white fibers on the inside  
surfaces.

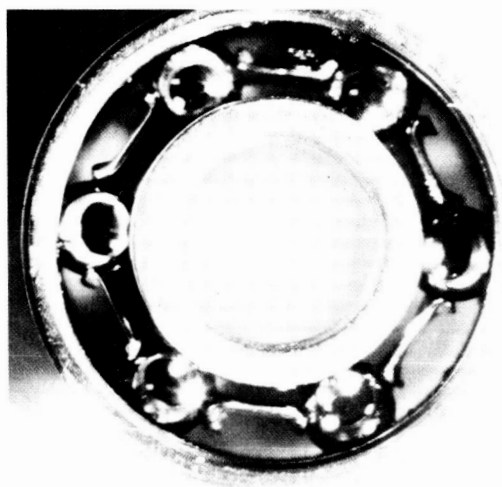
Figure 3  
Pressure Roller Bearing No. 1

Thick, brown, molasses-like  
appearing lubricant residue.

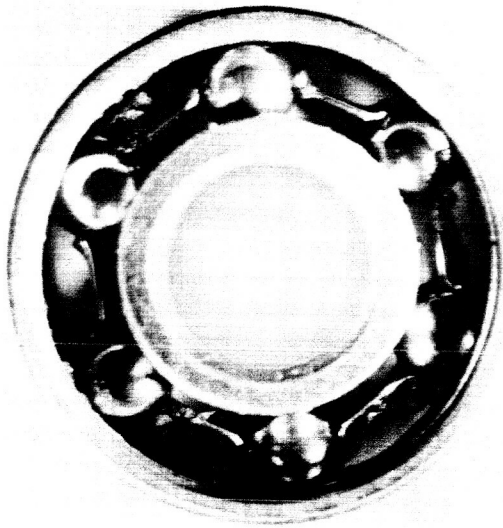
Figure 4  
Pressure Roller Bearing No. 2

Thick, brown, molasses-like  
lubricant residue.

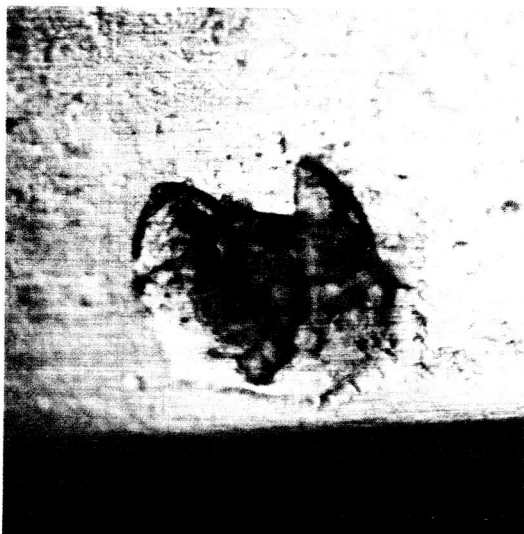
Figure 6

Magnified view of a gummy, brown  
deposit on the inner land of the  
rubber roller Bearing No. 1.

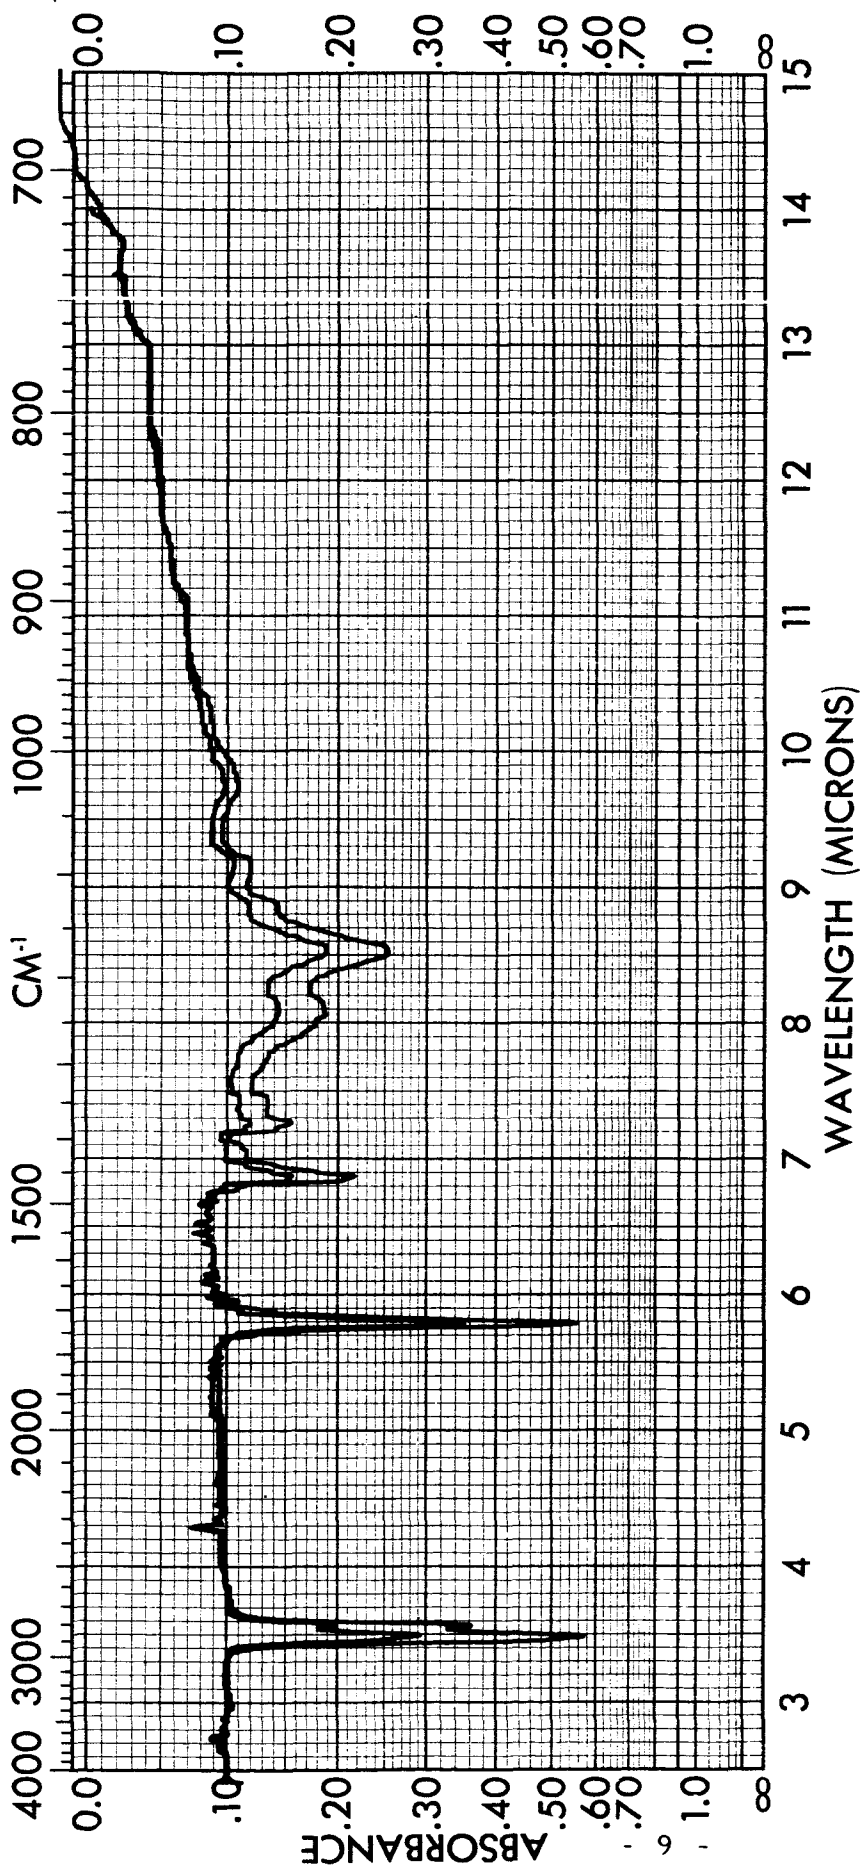
Figure 7    An infra-red spectrographic trace of a reference sample of L-245X oil meeting Mil-L-6085A specification.

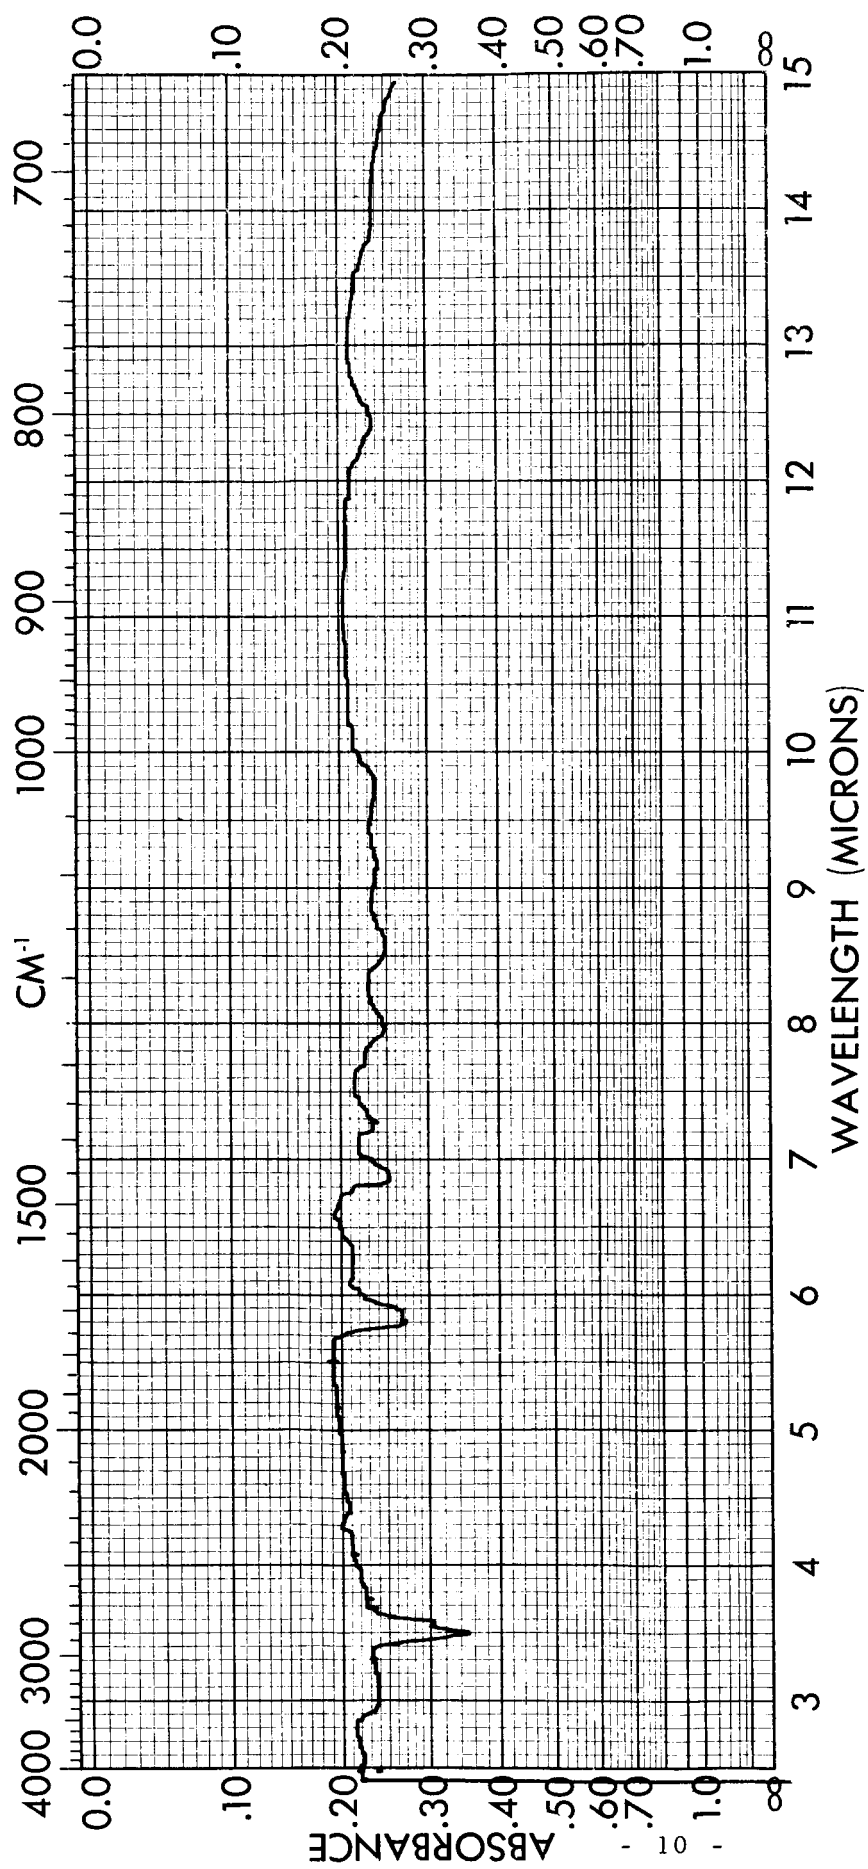
Figure 8    An infra-red spectrographic trace of lubricant from two bearings (601 - 15.11 and 601 - 35.2) from the playback switch gearbox assembly showing a broad band and 5.8 to 5.9 microns indicating oxidation. Neither the bearings or the oil, however, are considered to be failures.

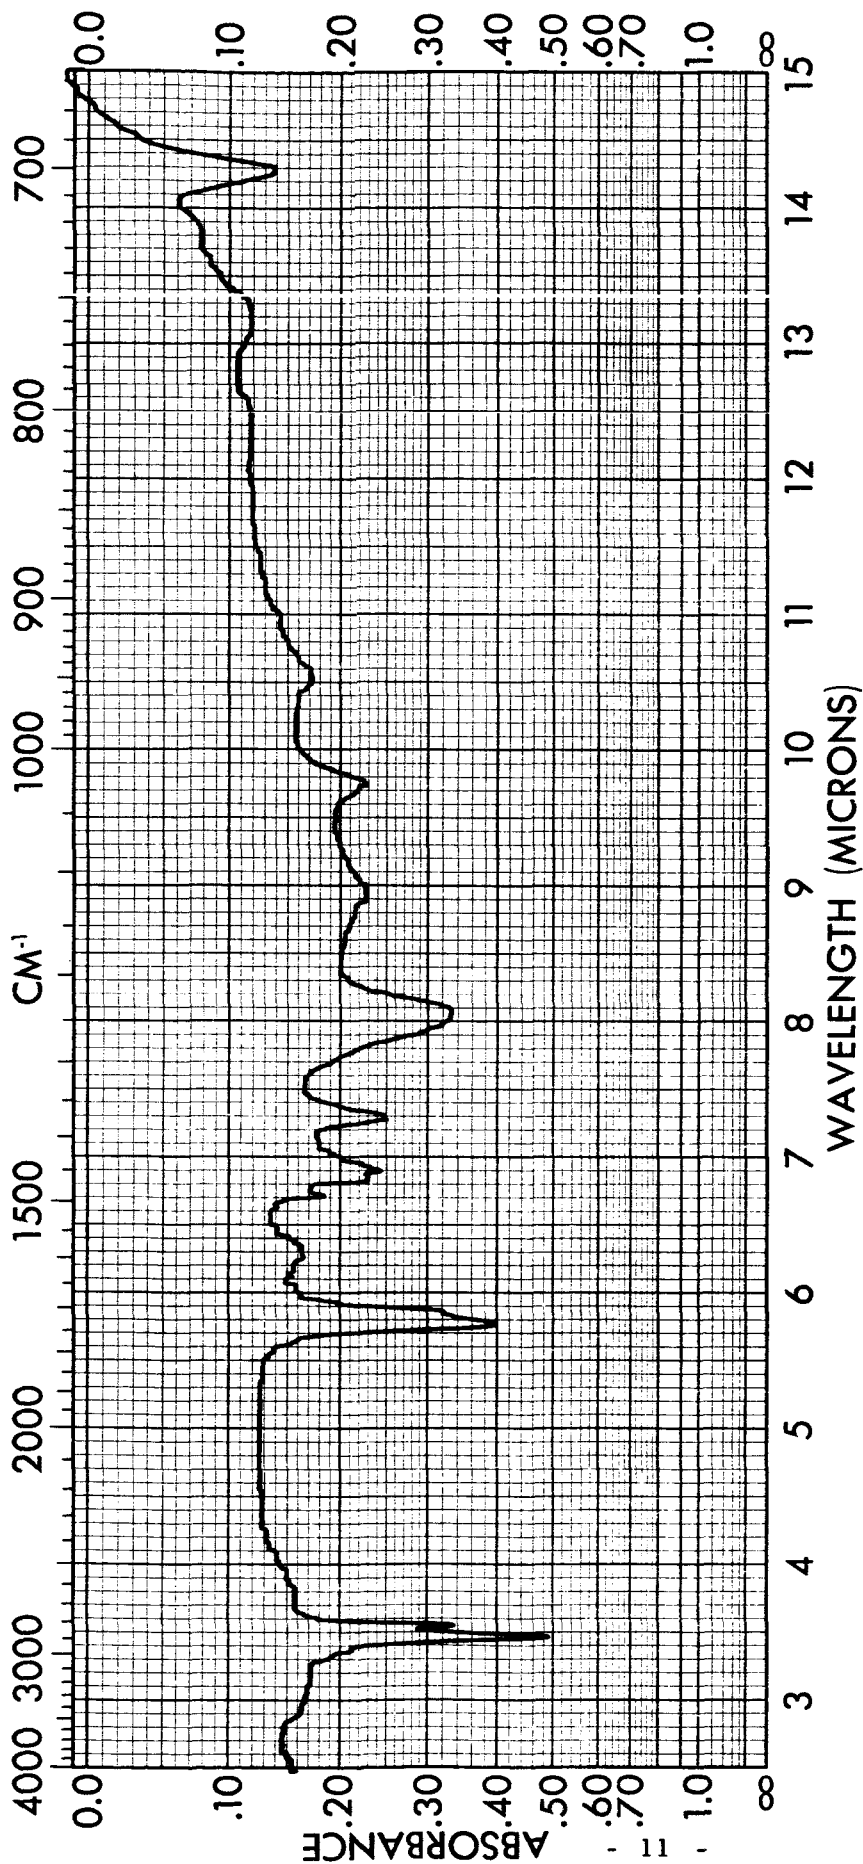
FIGURE 9

Figure 9    An infra-red spectrographic trace of the residue from a failed bearing showing definite oxidation. The bearing is from the pressure roller assembly (616 - 3 ) Unit 609. This is the infra-red spectrum of an aliphatic ester. There are bands 6.3 and 6.8 that are usually aromatic. The carbonyl peak is doubled indicating two carbonyl materials. The 3.0 region shows an alcohol. Taking the spectrum as a whole, it is consistent with an ester where some oxidation has taken place.
